Thredbo self-guided road collapse walk

Thredbo self-guided memorial walk

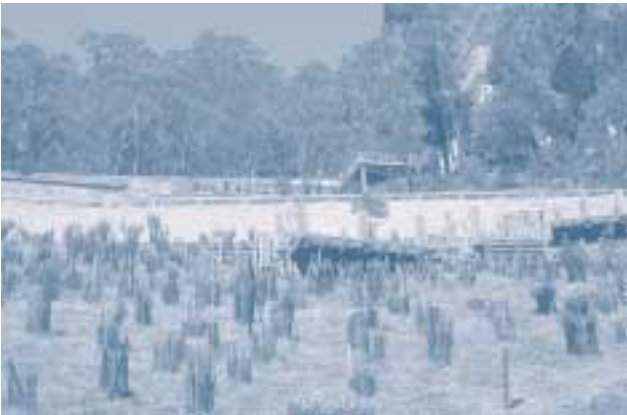
This observation point gives a direct view of where the road collapse occurred and the subsequent stabilisation and revegetation works. It was from this point that the television crews covered the story of the road collapse and the rescue of the only survivor, Stuart Diver.

At the rear of the site is a series of gabion rock retaining walls that have been constructed to stabilise the site after the Kosciuszko Alpine Way collapsed onto it and also to support the Kosciuszko Alpine Way above. Two lodges were located on the site. The original foundations of the upper lodge, Carinya, can be seen to the left at the top of the site.

Nothing remains of the second lodge Bimbadeen. Bimbadeen was located below Carinya, separated by Bobuck Lane, which is now supported by the large concrete retaining wall visible running across the middle of the site. Eighteen people were in Bimbadeen and one person was in Carinya on the night of the collapse. Seventeen people lost their lives in Bimbadeen and one person in Carinya.

The area has now been stabilized with extensive engineering works in the form of retaining walls, drainage and revegetation with native grasses, bushes and trees. The buildings at the base of the site were fortunate to escape damage.

View of site from lower observation point

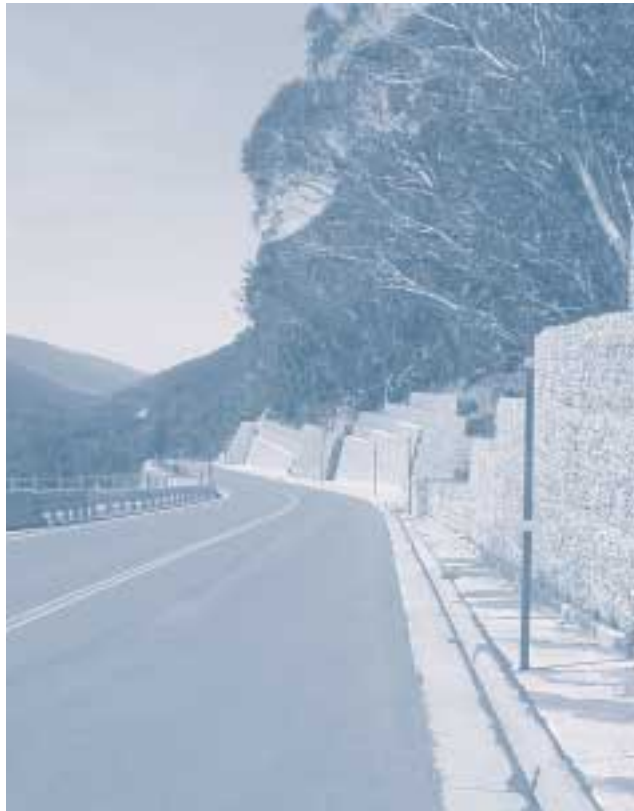
Gabion Walls

Below the blue steps is a good location to observe the construction of a gabion wall. Each rock is hand stacked into the wire baskets to produce a solid structure. Gabion walls allow the drainage of ground water through them but have similar retaining properties to reinforced concrete retaining walls. The walls are founded on engineered concrete footings and constructed from individual wire mesh "baskets" that are tied together with wire and then packed with stones. The baskets are then tied back into compacted earth behind the baskets, forming a gravity retaining structure.

The magnitude of the stabilisation work is evident from this viewing point. The gabion walls extend as far as the eye can see on both sides of the Kosciuszko Alpine Way. Approximately \$AUD24 million was spent on this extensive work.
